Notat: Utredning av høye rekkverk på Askøybrua

Vedlegg 6:

Erskine Bridge Parapet Replacement.

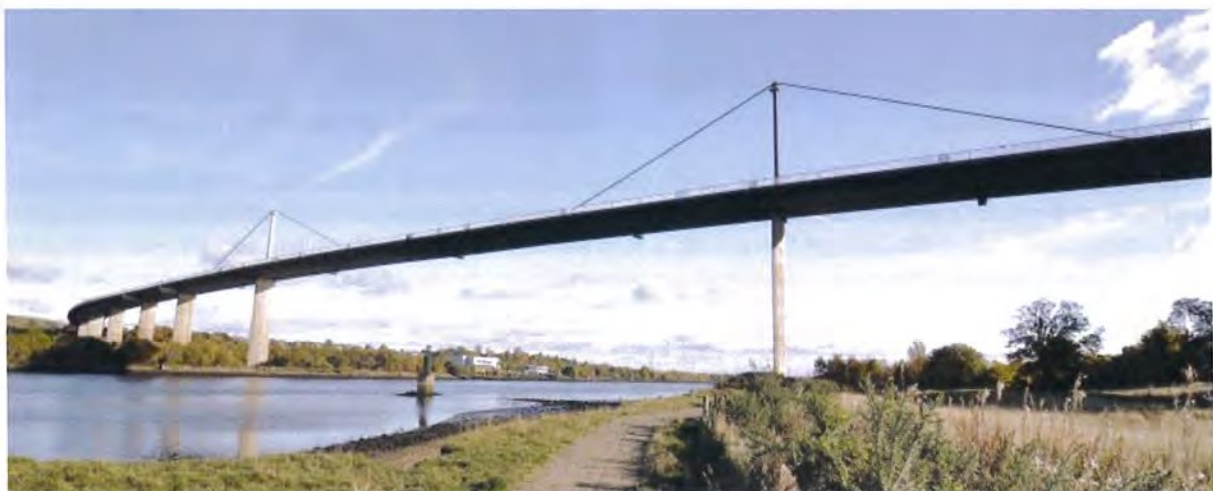
Figure 1: Erskine Bridge with the new parapets installed

The bridge is 1.3km long and has 15 spans. The main span is 305m, with 110m anchor spans either side and 68m approach spans^[1]. It is a high level crossing with the deck approximately 60m above the river, see figure 1.

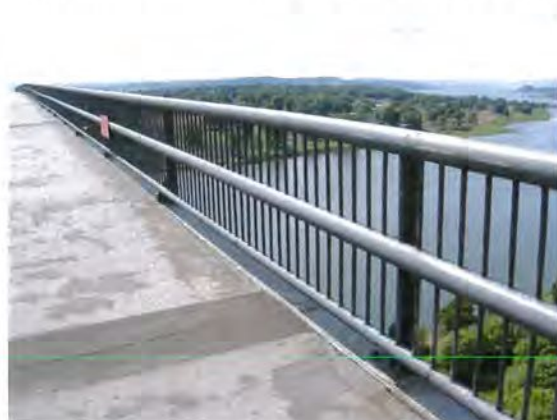
Ever since the bridge opened to traffic in 1971 there have been frequent incidents of people jumping or intending to jump from the bridge to commit suicide. The original bridge parapet was 1.2m high with three horizontal rails, see figure 3a, which made it very easy for people to climb up and over the parapet.

Figure 3a: Original Parapet

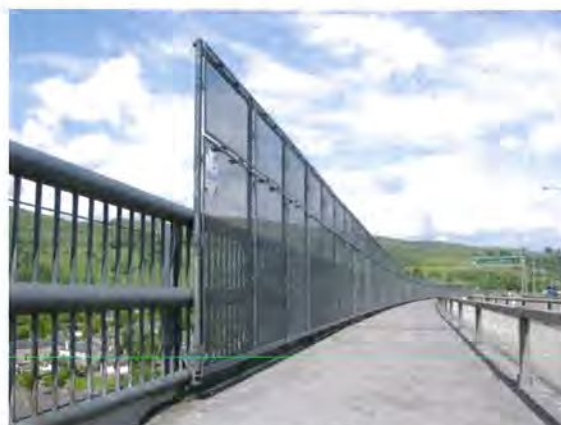
Figure 3b: Mesh screen over Old Dumbarton Rd

In an attempt to solve both of these issues, a 1.7m high mesh screen was added to the existing parapet in 1983/4 as an anti-climb measure for a 200m length of the bridge. However this was insufficient to prevent all suicides onto the residential area below. The screening was subsequently raised in height in three separate stages, so that by 1994/95 the height was 2.3m high, see figure 3b. This achieved the aim of protecting the road and residents below, although effectively only displacing the suicide problem further along the bridge.

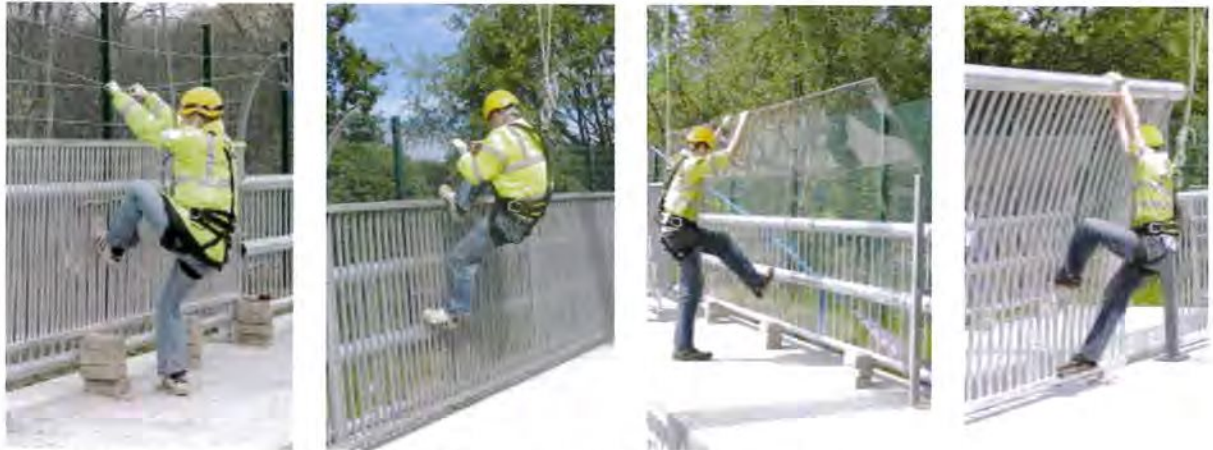
Solutions at other bridges were considered^[5], although due to the unique nature of the existing parapet, there were no off-the-shelf solutions available. In order to develop a workable design it was decided to carry out climbing trials. A length of replica parapet was constructed in the bridge maintenance compound, and a number of prototype extensions and replacement options were erected and tested for climbing resistance, see figures 4a to 4d.

Figures 4a to 4d: Climbing trials on prototype extensions and replacements

The result of the climbing trials and consultation were:

- Replacement options performed much better than extension options. It was found to be difficult to prevent the climber gaining a foothold on the middle or top rails of the existing parapet. Also the paint system on the existing parapet had come to the end of its useful life and any retention would require full maintenance painting, Extension options were effectively eliminated from further consideration.

- Of the replacement options, the curved parapet was more difficult to climb. Although some of those trying were able to get over eventually it required a lot of effort and determination by the climber. The next best was the wire topped parapet, with the acrylic screen being the easiest of the three

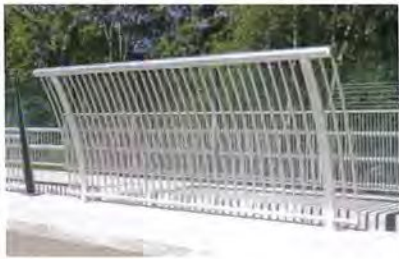
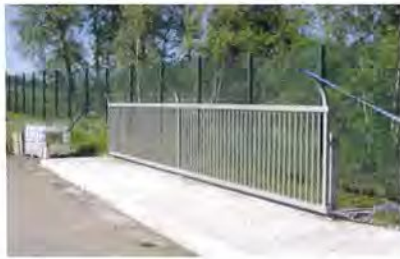
Style	Curved parapet		Parapet with tensioned wires

Material	aluminium	galvanised steel	aluminium	galvanised steel
Climbability	Very difficult	Very difficult	Difficult	Difficult
Aerodynamics	Satisfactory	Satisfactory	Satisfactory	Satisfactory
Buildability	Good	Good	Good	Good
Ease of maintenance	Good	Good	Good	Good
Construction cost	Highest	Medium	Lowest	Medium
	Note: little difference between any of the estimated costs			
25 year maintenance cost	Acceptable	Acceptable	Acceptable	Acceptable
Aesthetics	Preferred	Preferred	Not preferred	Not preferred
Resistance to vandalism	Vulnerable to graffiti only	Vulnerable to graffiti only	Wires subject to vandalism	Wires subject to vandalism
Project/safety risks during construction	Low risk	Low risk	Low risk	Low risk
Sustainability	Most environmental cost	Low environmental cost	High environmental cost	Low environmental cost

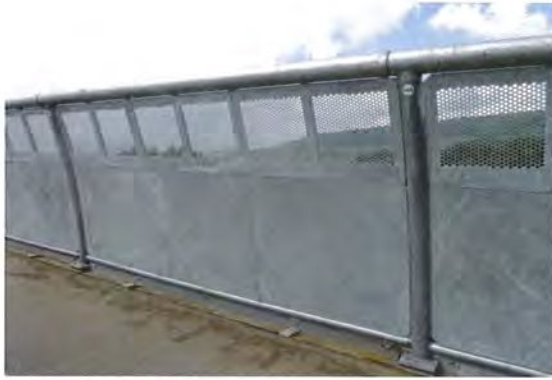
Two variations on the parapet design were required. One of the approach spans crosses an electrified railway, and a version of the parapet with solid infill up to 1.5m above deck was developed in order to comply with current UK standards, see figure 5a. Due to the problem of vandalism around the Old Dumbarton Road as noted in section 2 above, a mesh screen version was developed for use over that length of the bridge, see figure 5b. Neither version was deemed suitable for the full length of the bridge owing to the increased wind effects this would put on the main span,

Figure 5a: Parapet over railway

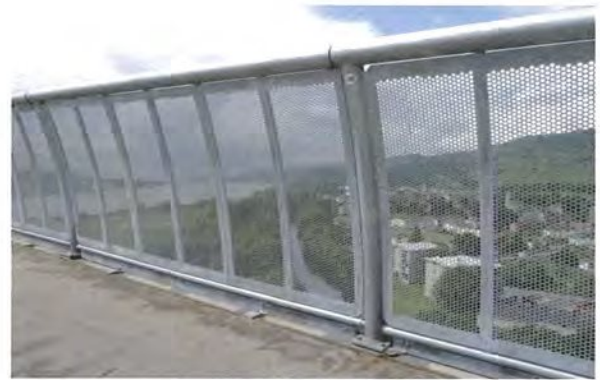
Figure 5b: Parapet over Old Dumbarton Rd

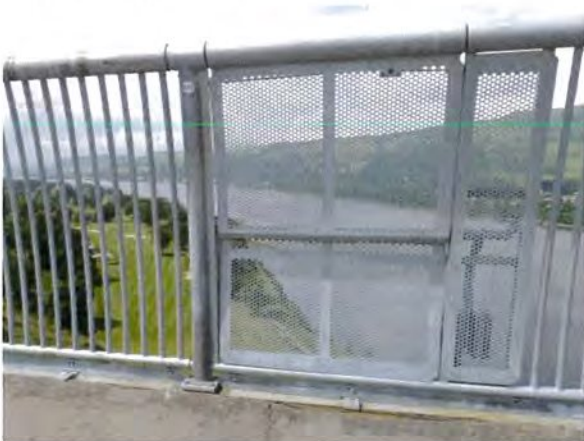
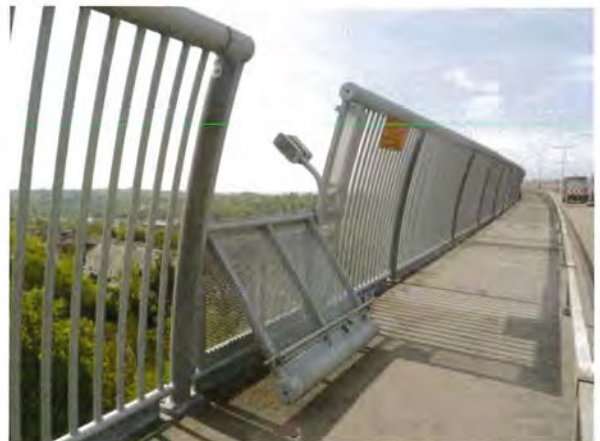
Two options were considered. One was to raise the level of gantry access to the top of the new parapet. A major modification to the gantry would be required to get up and over the 2.4m high parapet. Any gantry extension would need to be out of reach to prevent it being used by the public, and the consequent complexity led to this option being discarded. The second option was to introduce gates at regular intervals along the parapet to preserve the existing means of access. A system was developed in which the upper half of a gate folds down leaving a bar at the original parapet top rail level, see figures 6a and 6b. This required very little amendment to the existing gantry. The gate was counterweighted to allow easy operation from either the footway or the gantry. Prototypes were developed and tested to ensure this was no easier to climb than the remainder of the parapet. There are 19 no. lockable gates on each side of the bridge.

Figures 6a and 6b: Gate for access to maintenance gantry

A solution was needed to preserve access to the maintenance gantries. There are four maintenance gantries suspended underneath Erskine Bridge and these are the main means of access to the bridge underdeck cantilever structure and services. The gantries were previously accessed by a drawbridge at the level of the original parapet top rail, and hence access would be greatly affected by the parapet replacement scheme.

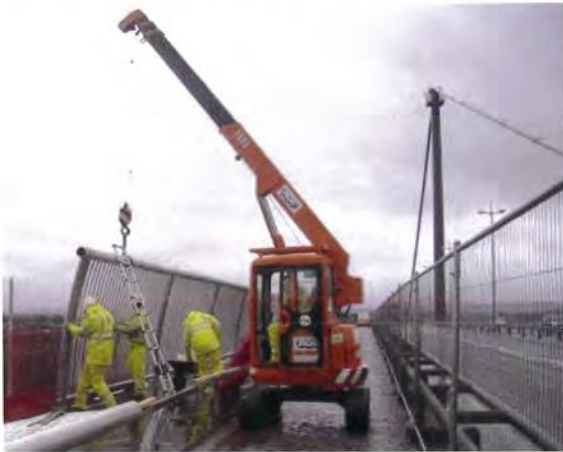
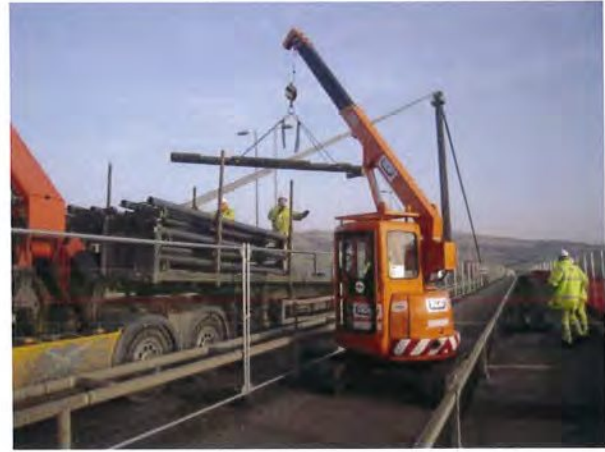
The construction of the bridge means that the footway is not capable of supporting any more than pedestrian loading. The cycleway is capable of supporting some vehicles but not unrestricted traffic. For that reason severe restrictions were imposed on the Contractor for any plant used for the works. The Contractor opted to use a 3-tonne miniature crane, a model CCH30T, see figures 7a and 7b. This crane was positioned in the cycleway and was capable of lifting the 500kg panels without overloading the deck.

Figures 7a and 7b: Miniature crane operating from cycleway

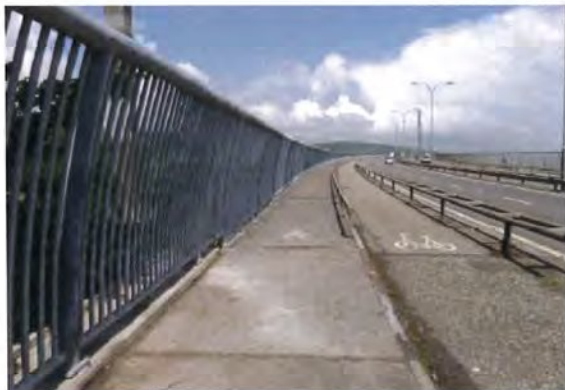
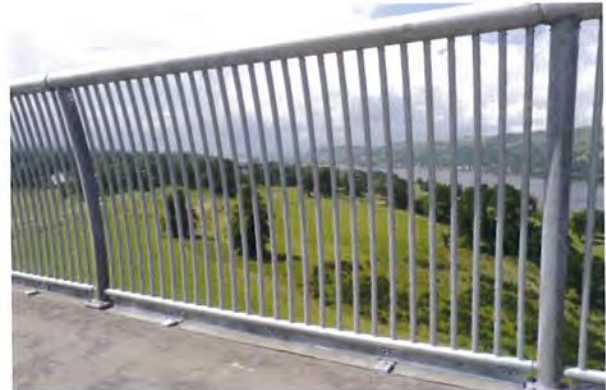
The works were completed in August 2012, see figure 8. Although Transport Scotland wished to avoid publicity of the scheme in order to discourage suicide attempts, completion was greeted with a favourable reaction from the local public, press and politicians.

Figures 8a and 8b: Completed parapet
