# ~ CONSTRUCTION & DEVELOPMENT ~ “ALDEA”

- OVERVIEW OF BUILDING
- BUILDING PLANS FLOOR 1
- BUILDING PLANS FLOOR 5
- BUILDING PLANS FLOOR 6
- BUILDING PLANS FLOOR 7
- REFERENCE FLOOR 4

We will rebuild 4 floors of the building in C.Sundts gate 55 to make a workshop (floor 1), a gallery (floor 1) and artist studios (floors 5,6,7). The rebuilding of all the floors will start in October 2017 and we aim at completing them in 3 months. All floors are 560 m<sup>2</sup>.

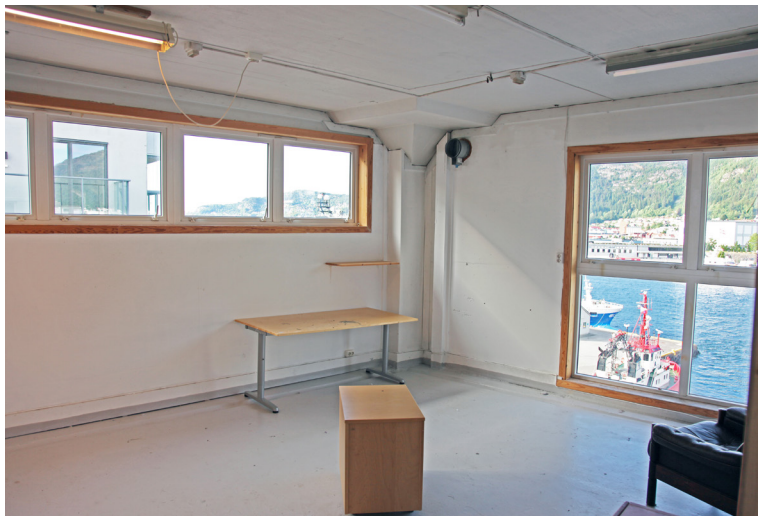
HOLES IN THE WALL FOR VENTILATION

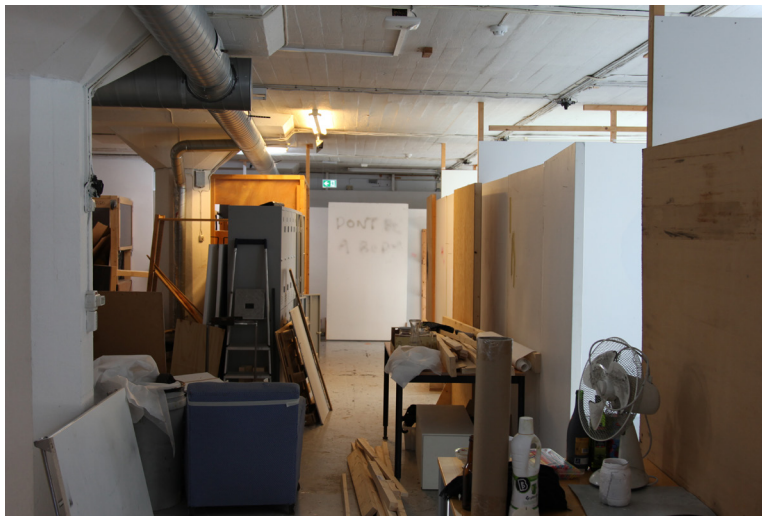
PARTIAL WALLS

This floor is today used as studios for master students at KHIB. Rooms are divided by half-walls, none of which can be used. Therefore we need to build many new walls on this floor. Apparently the electricity is “a mess” so it must be redone. Fuse box with ceramic fuses must be replaced with new fuse box. On the wall facing the water there is an “aggregat” for friskluft, kald tilluft. This floor has an existing, independent and functional fire alarm system which will not need alteration or upgrade.

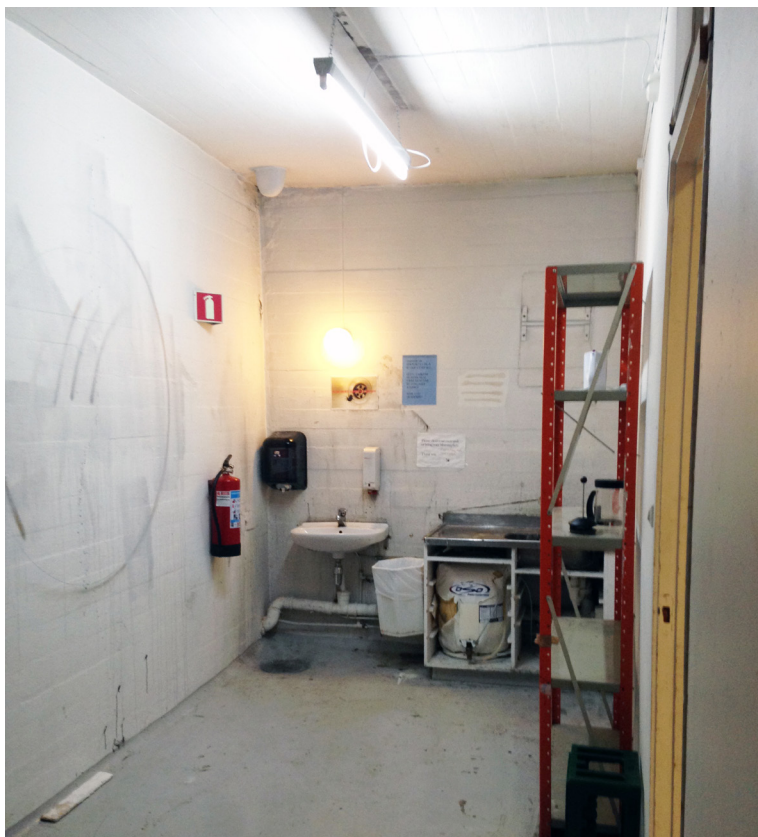
ROOM FOR NEW TOILET AND KITCHEN

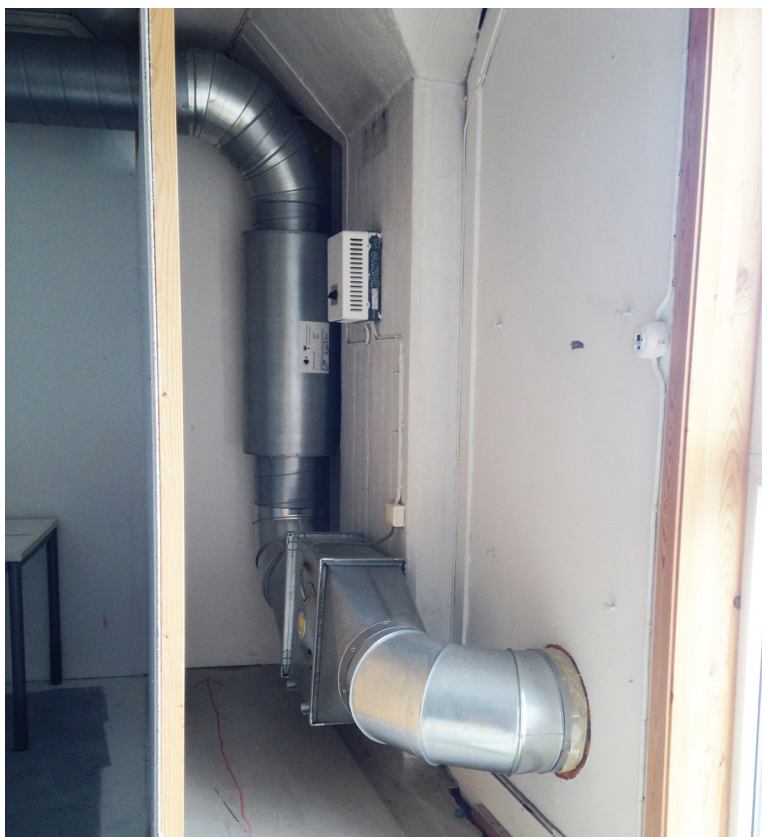
AGGREGAT TIL-LUFT KALD

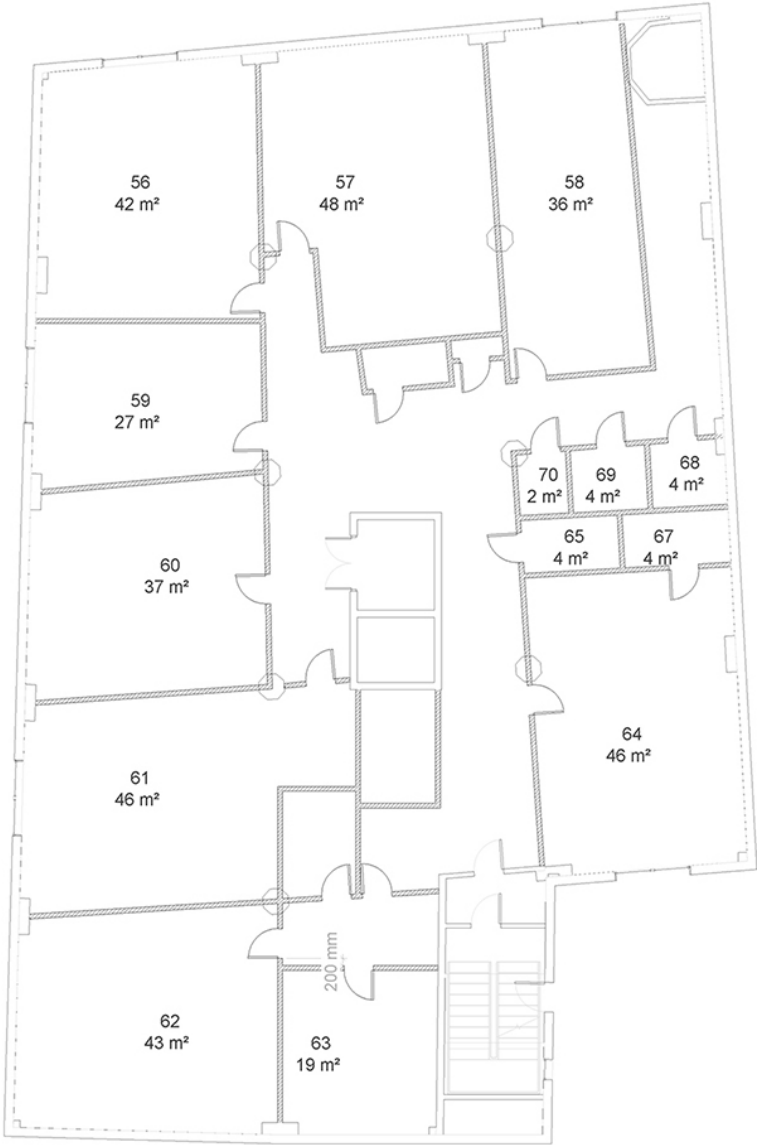
This floor is today part of artist collective Kunstnerverksteder Cs55 and is not included in our project, but functions as reference model for how we want to organize floor 5, 6 and 7. One difference is that we want windows/plexi glass on the top part of the walls that face into the middle of the space so that we can get more daylight into the center area of each floor. Another difference is that we will place the kitchen and toilet according to where water is already installed in order to reduce cost.
